DEVELOPMENT OF SILICON NITRIDE OF IMPROVED TOUGHNESS

by J.J. Brennan

UNITED TECHNOLOGIES RESEARCH CENTER

FINAL REPORT

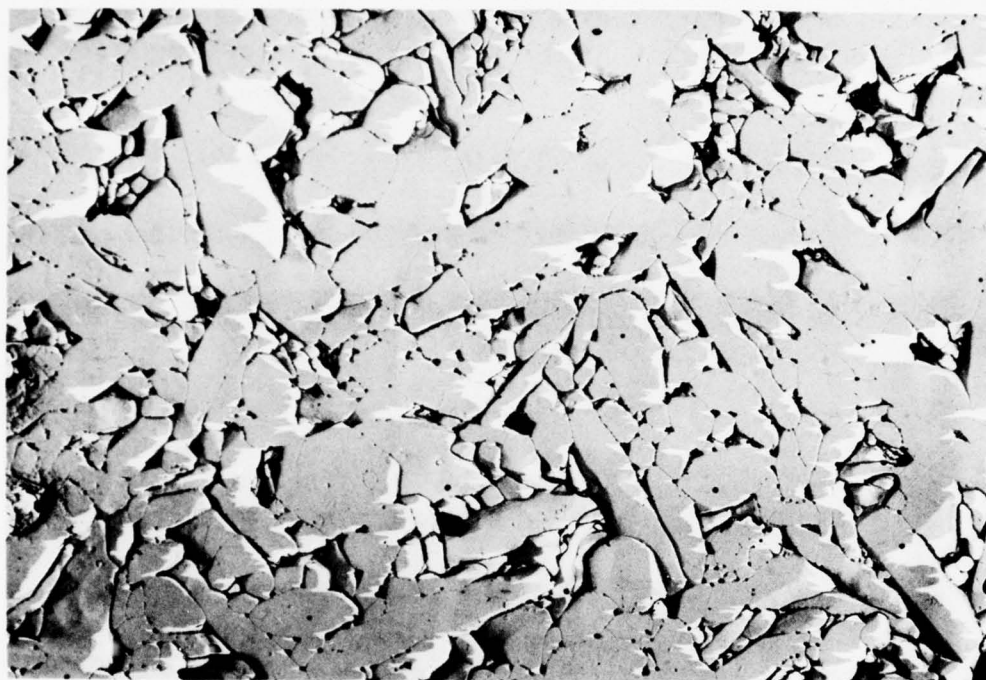
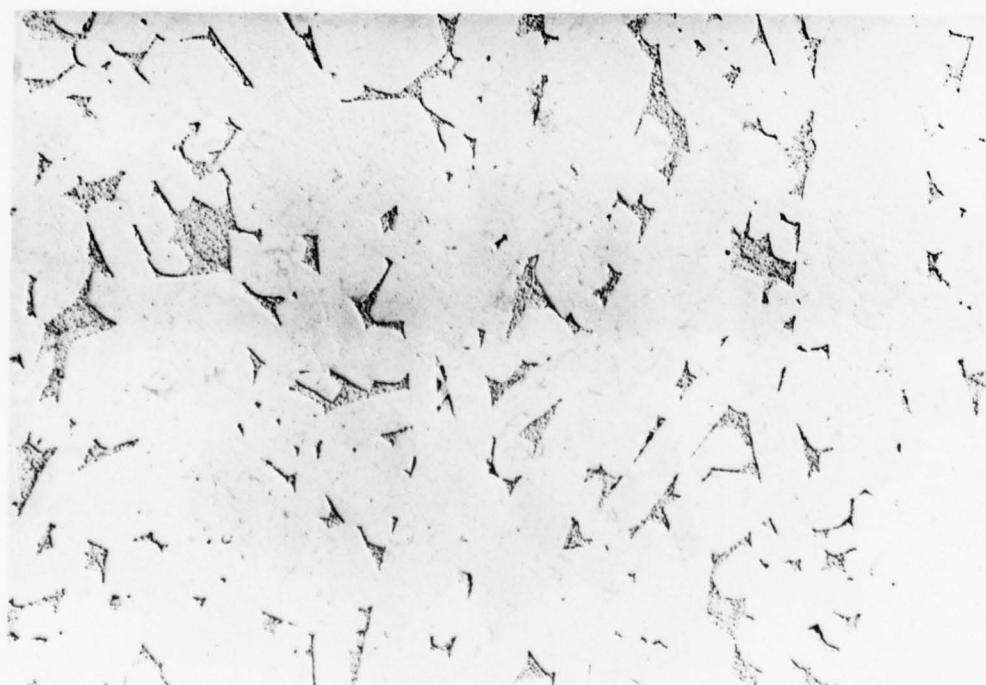
MICROSTRUCTURE OF NC-132 (a) AND NCX-34 (b) HOT-PRESSED Si_3N_4 (TEM REPLICA)

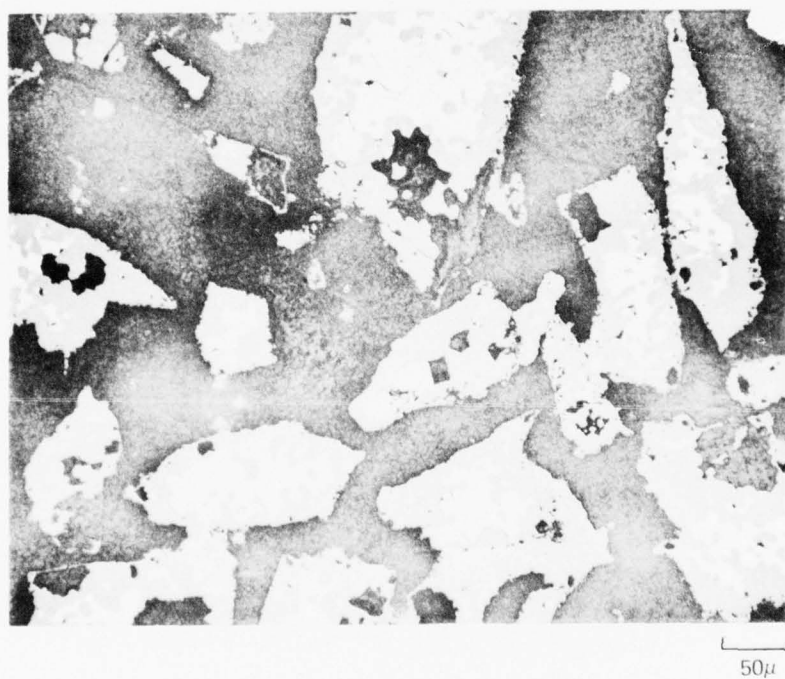
RSSN LAYER (-100, +200 Si) NITRIDED TO 1375°C, 24 HRS, N₂
(25-30 V/O UNREACTED Si)

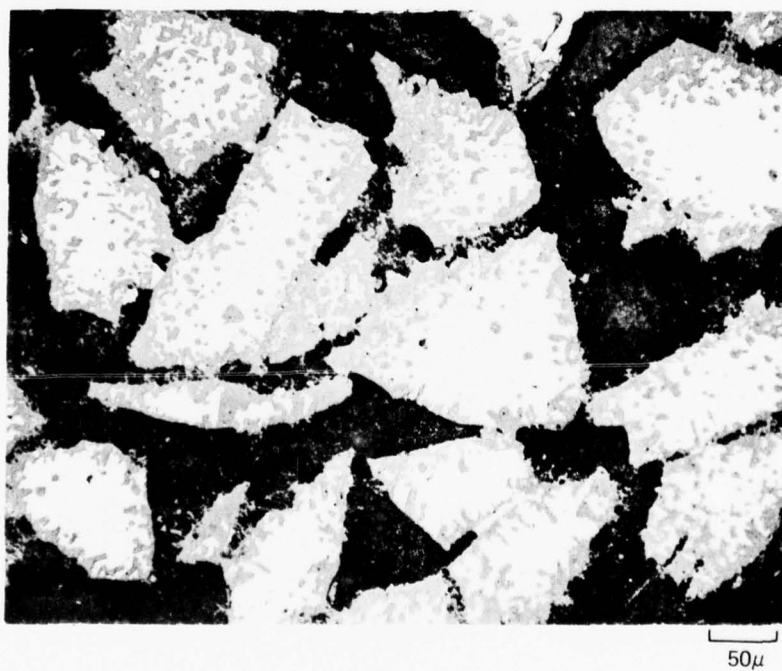
RSSN LAYER (-100, +200 Si) NITRIDED TO 1375°C, 8 HRS, N₂
(60 V/O UNREACTED Si)

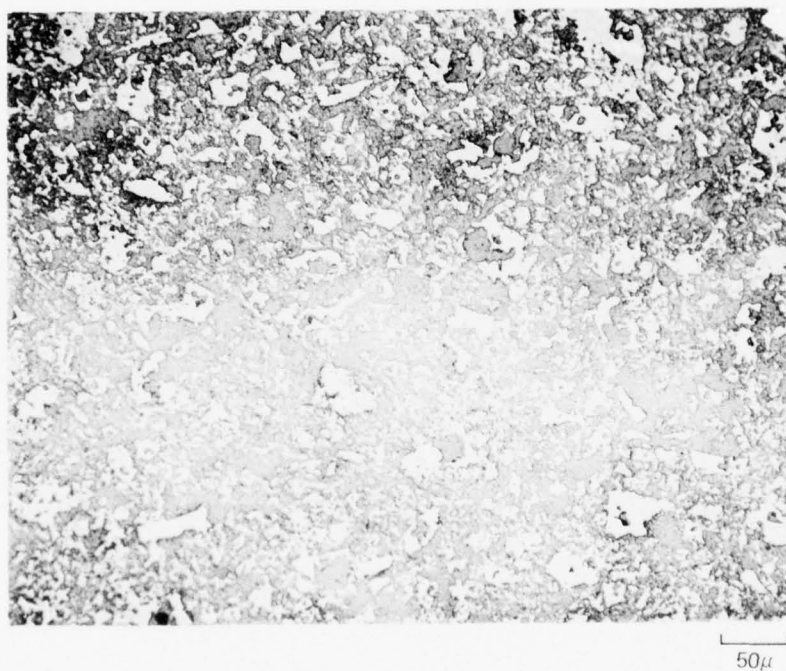
RSSN LAYER (-325 Si) NITRIDED TO 1375°C, 8 HRS, N₂
(Si COMPLETELY NITRIDED)

The results of RT ballistic impact tests on the samples nitrided to 1375°C for 8 hrs are given in Table VIII. As in the case of -100,+200 Si layers nitrided for 24 hrs at 1375°C, an impact energy in excess of 11.4 joules was necessary to fracture the NCX-34 Si_3N_4 substrates. However, the nitrided -325 Si layers could only withstand up to 6.2 joules before the substrate fractured. From X-ray analysis and optical microscopy of the nitrided layers, it was found that the 8 hr, 1375°C nitriding schedule resulted in approximately 60% unreacted silicon within the large β - Si_3N_4 grains of the -100,+200 Si nitrided layer (Fig. 8), while the -325 Si nitrided layers were essentially completely nitrided (Fig. 9) to a mixture of ~65% β , 35% α - Si_3N_4 .

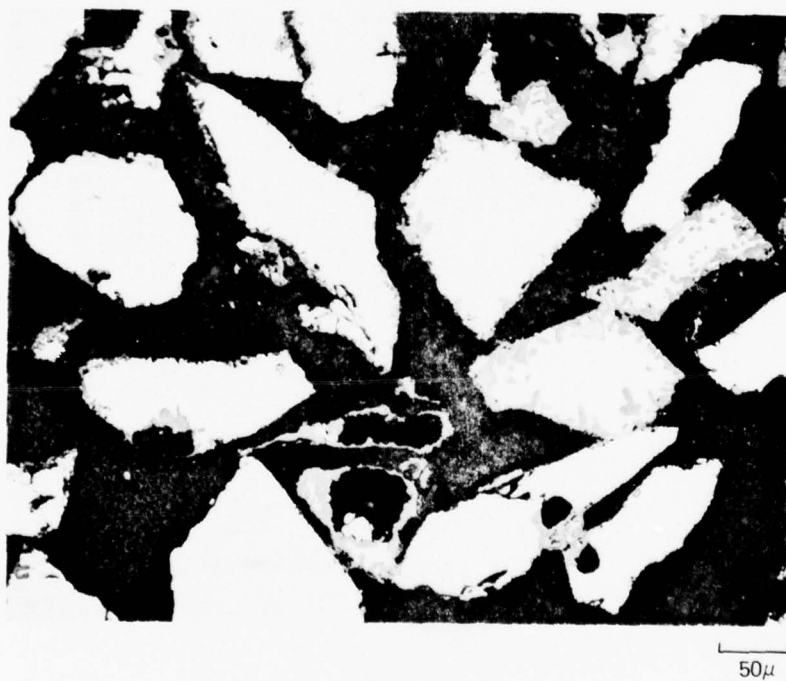
RSSN LAYER (-100, +200 Si) NITRIDED TO 1300°C, 8 HRS, N₂
(10 V/O OF Si CONVERTED TO Si₃N₄)

The -100,+200 Si samples that were deliberately nitrided to only 1300°C, 8 hrs, exhibited RT ballistic impact resistance less than the -100,+200 Si samples nitrided to 1375°C, 8 hrs. They were also somewhat friable, indicative of poor particle-to-particle bonding. From X-ray analysis and optical microscopy it was evident that very little of the Si had been converted to Si_3N_4 (~10 vol %), as shown in Fig. 10. Not enough Si_3N_4 had been formed to bond the particles together, thus resulting in the observed friable layer.

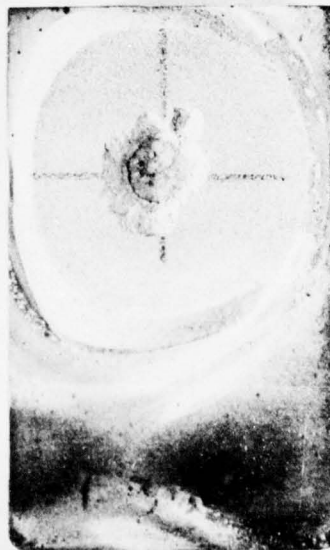
BALLISTIC IMPACT SAMPLE OF NC-132 Si_3N_4 WITH -200 RSSN
LAYER AFTER 9.1 JOULE IMPACT

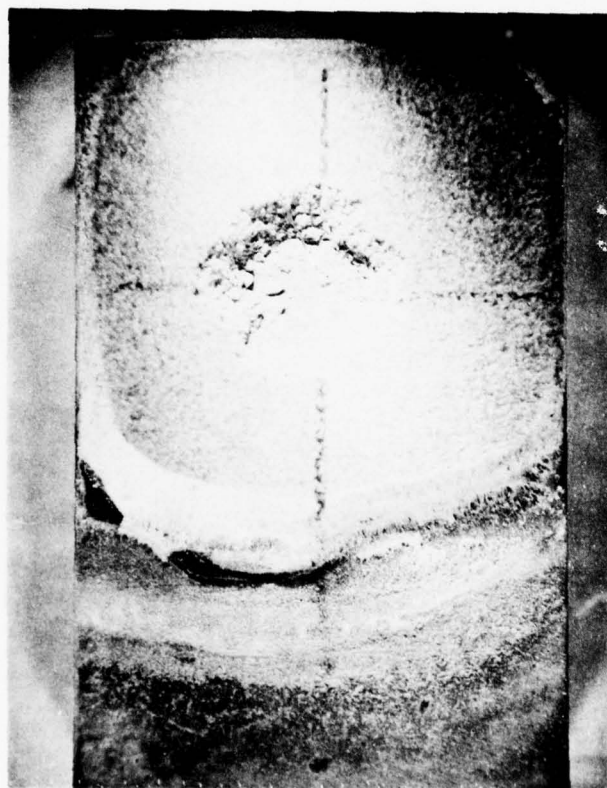
BALLISTIC IMPACT SAMPLE OF NCX-34 Si_3N_4 WITH -200 RSSN
LAYER (21 V/O Si) AFTER 15.4 JOULE IMPACT

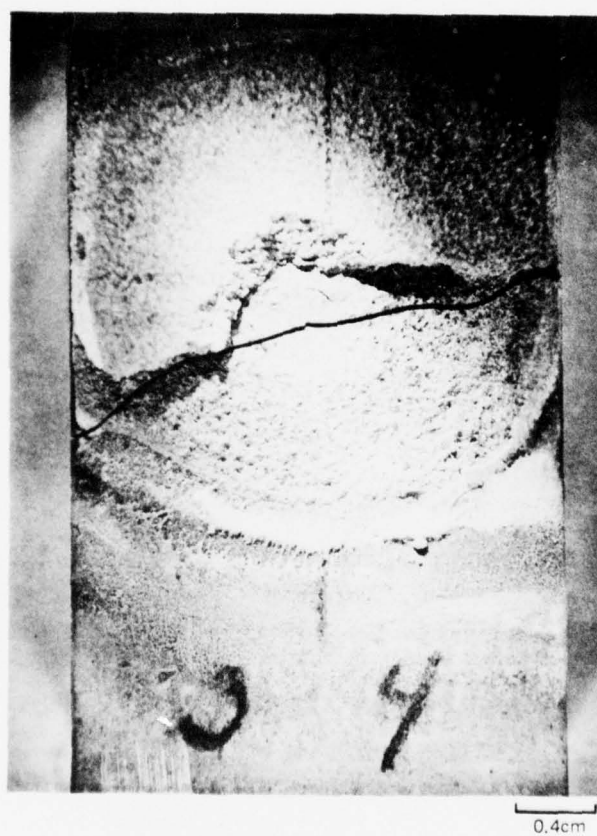
BALLISTIC IMPACT SAMPLE OF NCX-34 Si_3N_4 WITH -200 RSSN
LAYER (21 V/O Si) AFTER 17.2 JOULE IMPACT

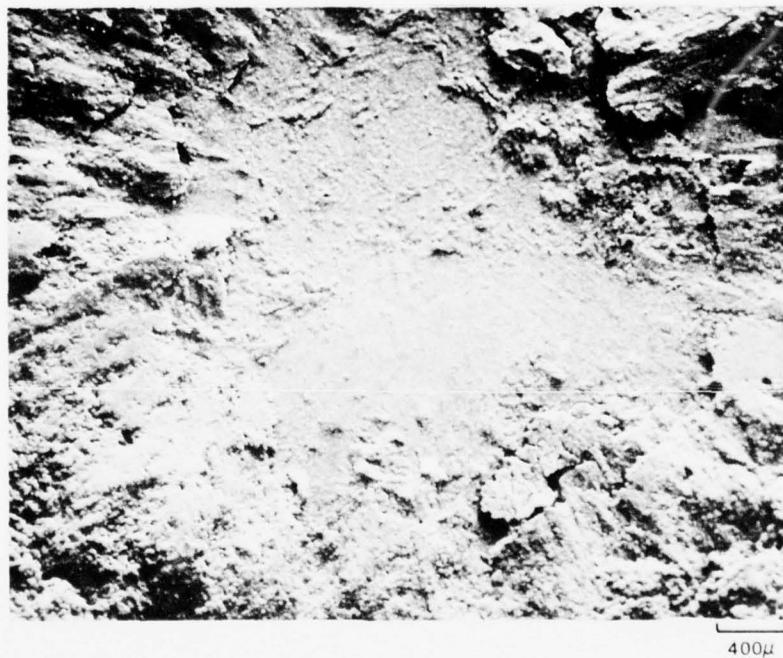
POINT OF IMPACT THROUGH A-200 RSSN LAYER DOWN TO THE HPSN SUBSTRATE
FOR A STEEL SPHERE TRAVELING AT 300M/SEC

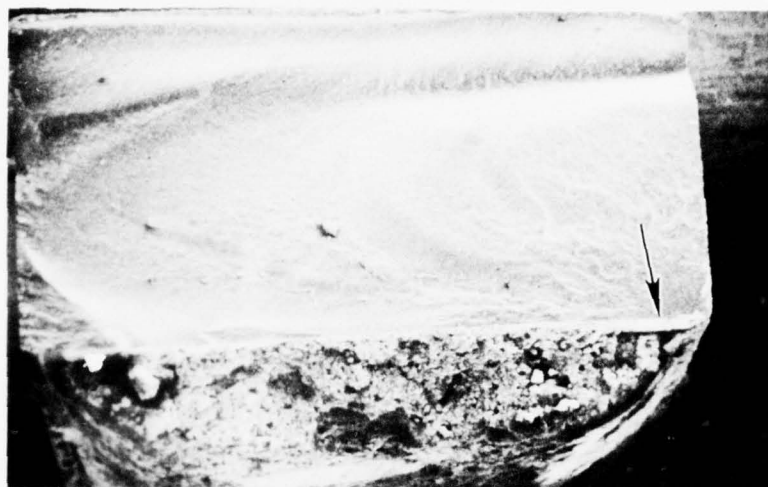
FRACTURE SURFACE OF NC-132 Si_3N_4 WITH -325 Si LAYER (NITRIDED AT
MAXIMUM TEMP. OF 1250°C FOR 24 HRS.)

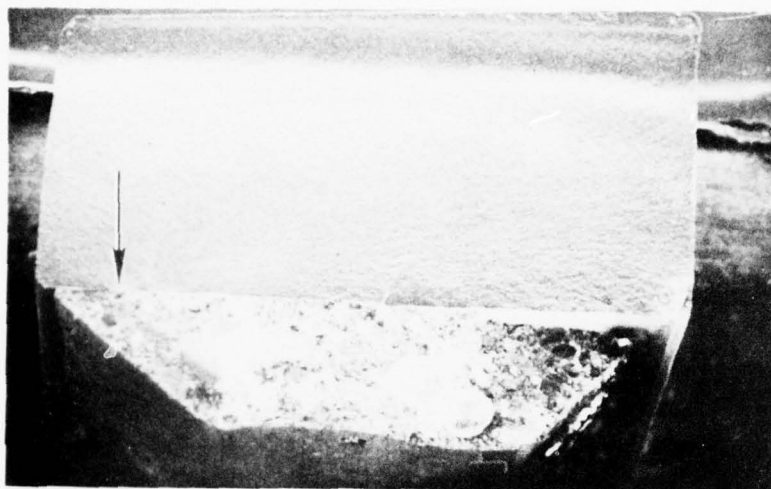
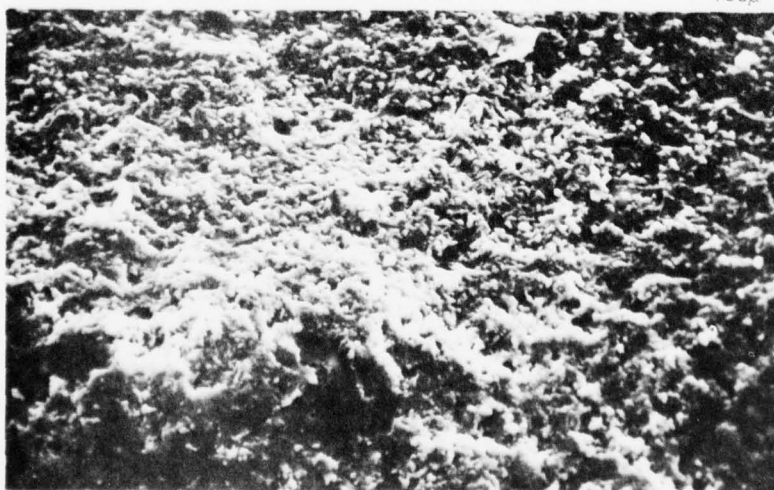
FRACTURE SURFACE OF NC-132 Si_3N_4 WITH $-\text{Si}$ LAYER (NITRIDED AT
MAXIMUM TEMP. OF 1375°C FOR 24 HRS.)

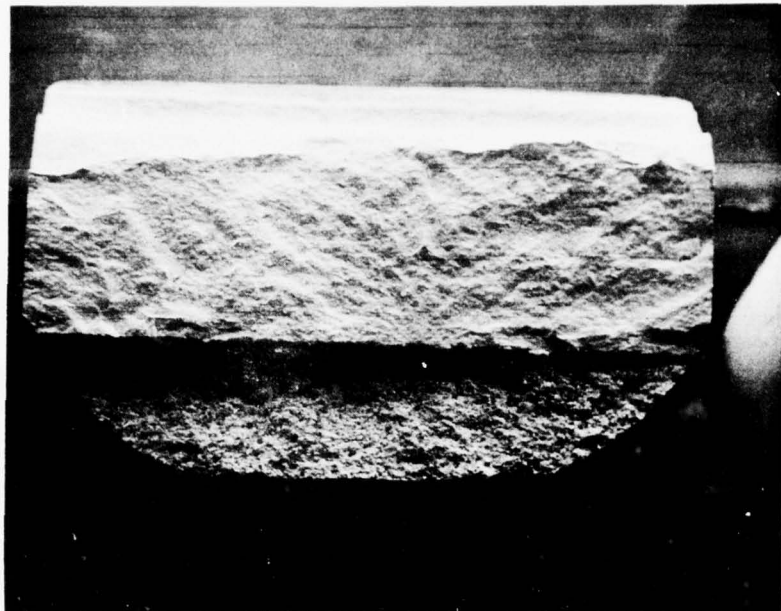
FRACTURE SURFACE OF POORLY BONDED RSSN LAYER (-325 Si , 98%) ON NCX-34 Si_3N_4 ,
NITRIDED TO 1375°C , 60 HRS, N_2

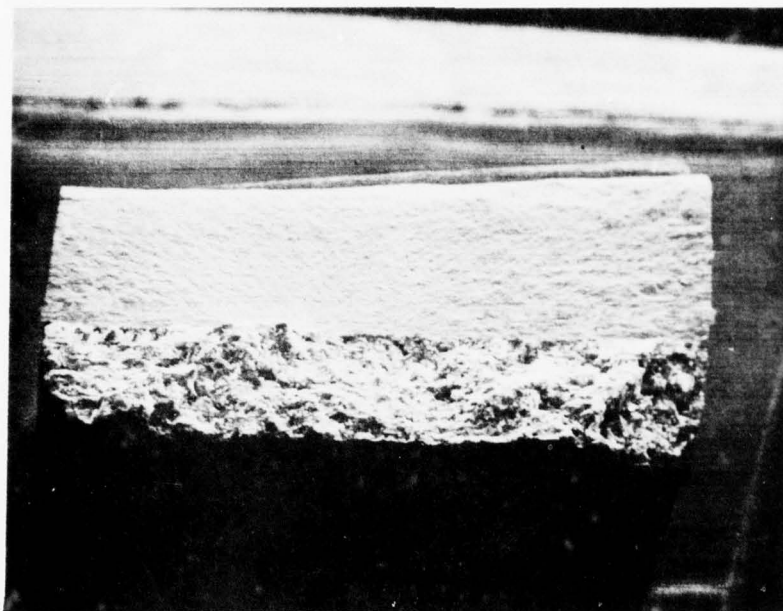
FRACTURE SURFACE OF STRONGLY BONDED RSSN LAYER (-100, +200 Si)
ON NCX-34 Si_3N_4 , NITRIDED TO 1375°C, 60 HRS, N_2

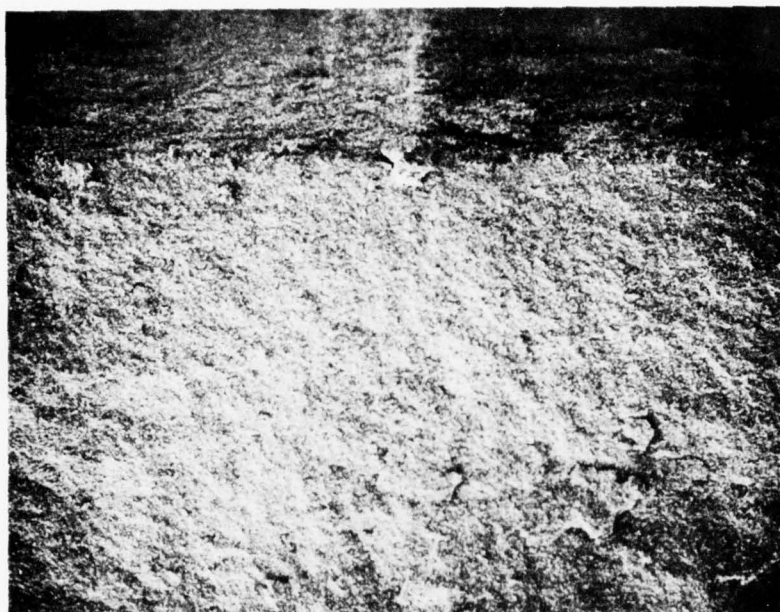
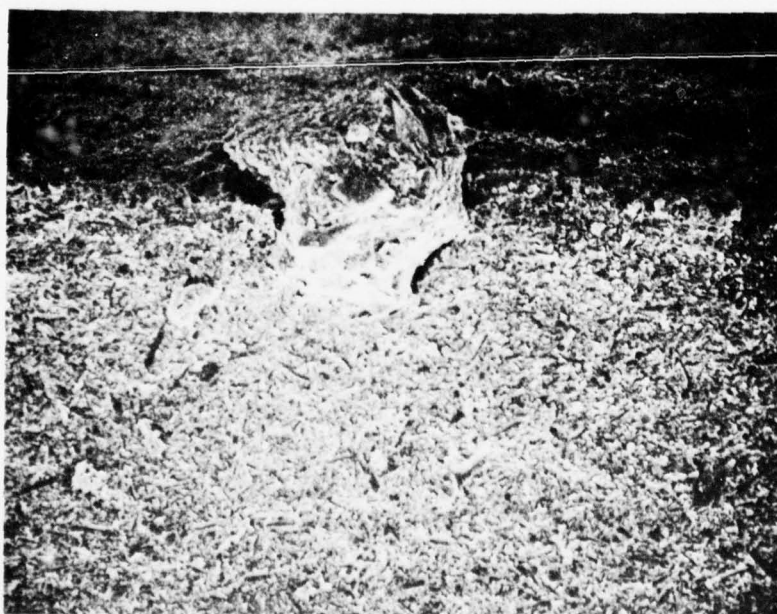
FRACTURE ORIGIN OF NCX-34 Si_3N_4 WITH LOOSE -100, +200 Si PARTICLES
ON THE SURFACE, NITRIDED TO 1375°C, 60 HRS, N_2

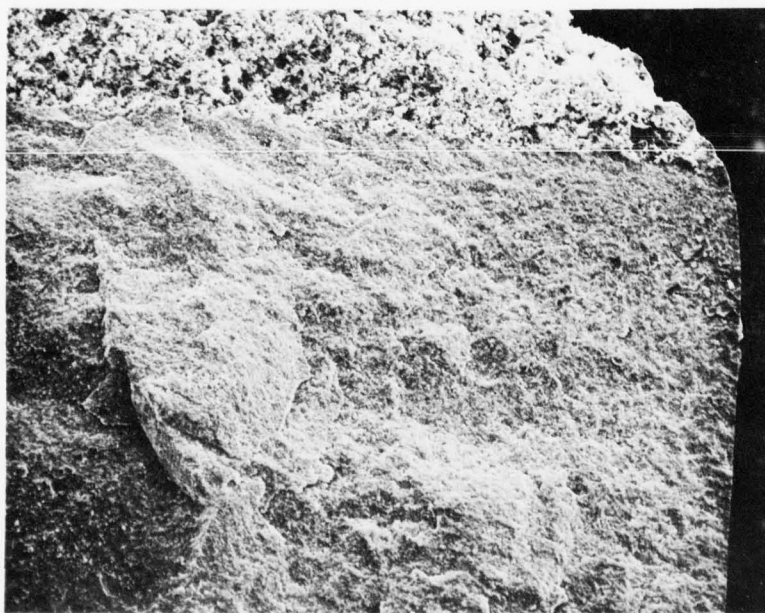
FRACTURE SURFACE OF -325 Si (98%) RSSN LAYER ON NC-132 Si₃N₄,
NITRIDED IN 96% N₂/ 4% H₂ TO 1375°C, 60 HRS

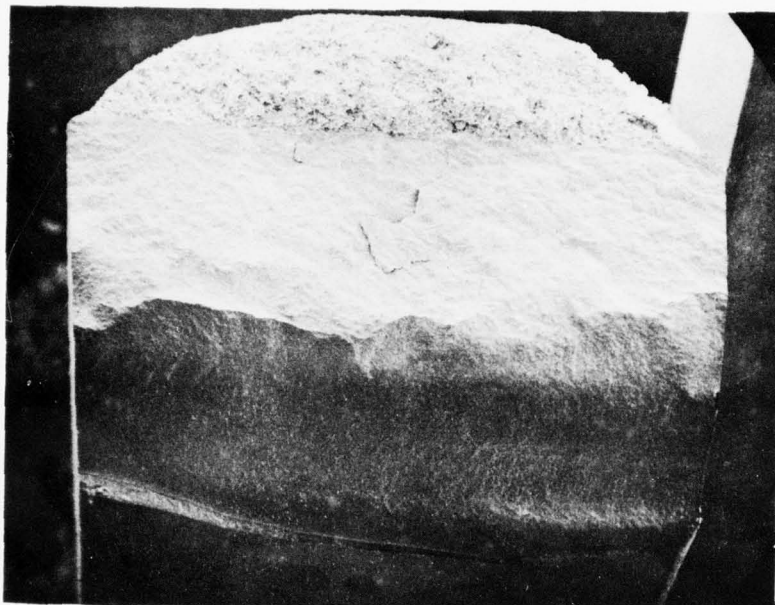
FRACTURE SURFACE OF -325 Si (98%) RSSN LAYER ON NCX-34 Si_3N_4 ,
NITRIDED IN 96% N_2 /4% H_2 TO 1375°C, 60 HRS

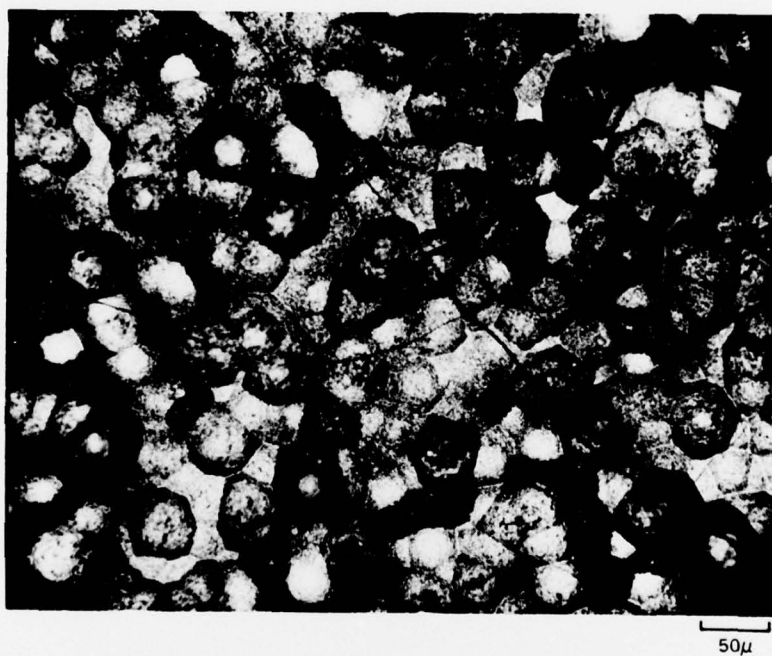
THICK (0.15MM) CVD Si C ON - 200 RSSN/HPSN BALLISTIC IMPACT SAMPLE

However, CVD SiC, which can be deposited at temperatures of 1100-1150°C, was successfully deposited on -200 RSSN layers. CVD SiC overlayers thicker than 50μ (2 mils) tended to crack severely on cooling from deposition due to thermal expansion mismatch, and on subsequent thermal cycling tended to spall, offering no protection from oxidation. CVD SiC overlayers of 12-25μ (0.5-1.0 mils) in thickness were deposited crack-free and, on thermal cycling, did offer substantial oxidation protection and no decrease in ballistic impact properties. While some internal oxidation of the RSSN layer still occurred, it is felt that an optimized CVD SiC overlayer could be extremely oxidation resistant.

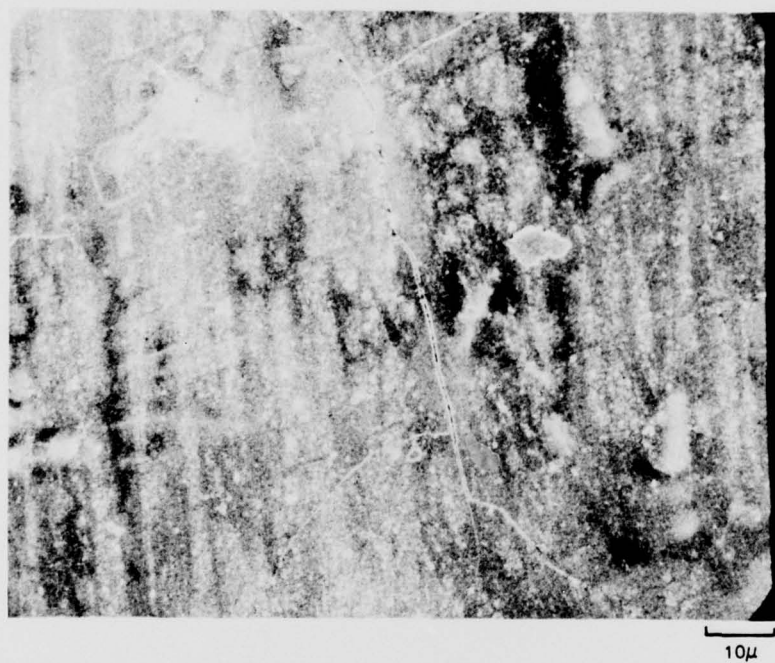
OXIDIZED SURFACE OF CVD SiC OVERLAYER AFTER 75 CYCLES TO 1370°C.

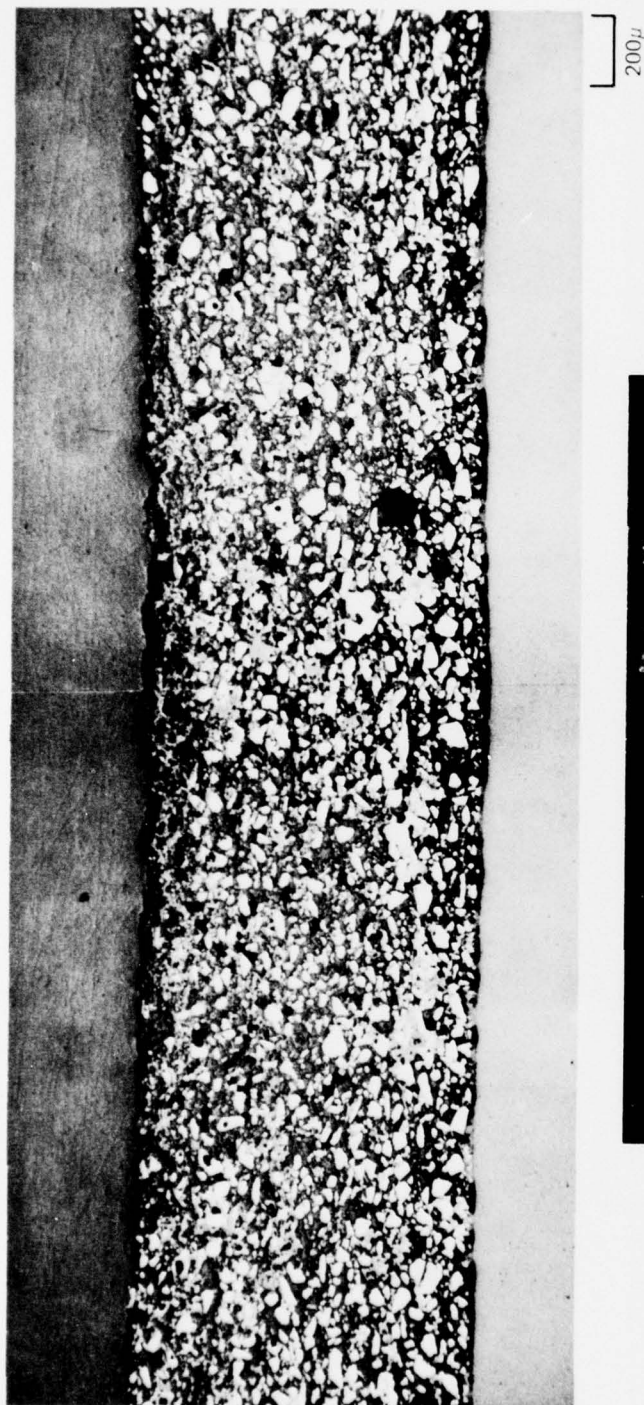
NC-132 Si_3N_4 WITH -200 RSSN LAYER (25% Si) AFTER 1370°C, 5 HR. MACH 0.8 EROSION TEST

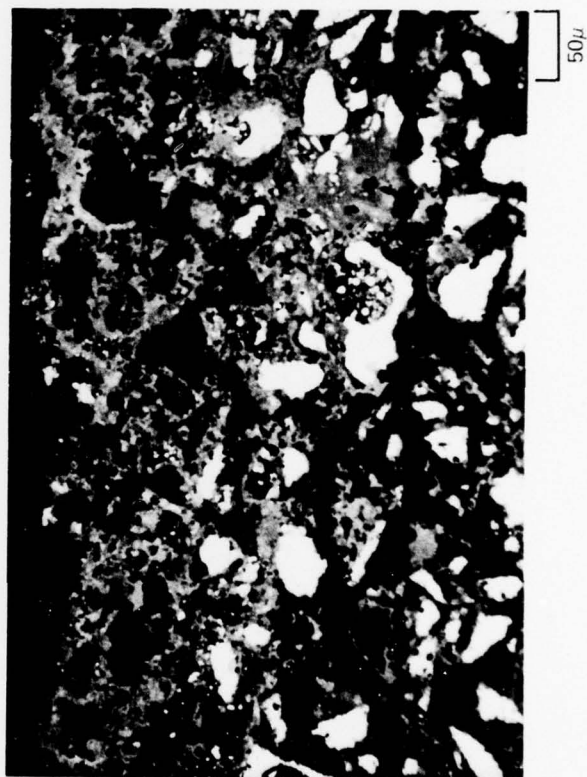
MOUNTING
MATERIAL

RSSN
LAYER

NC-132
SUBSTRATE

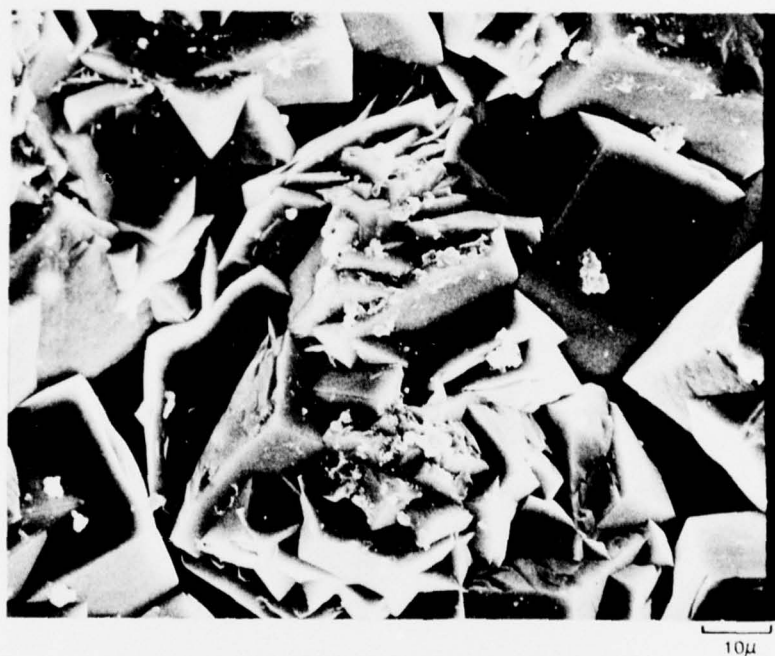
SURFACE OF CVD Si_3N_4 OVERLAYER ON A -200 RSSN/HPSN EROSION SAMPLE.
